1 Reason for update

This update has been made to allow the PMU's CAN address to be read and written from the configuration software. Prior to this update the CAN address had to be set using the CAN interface.

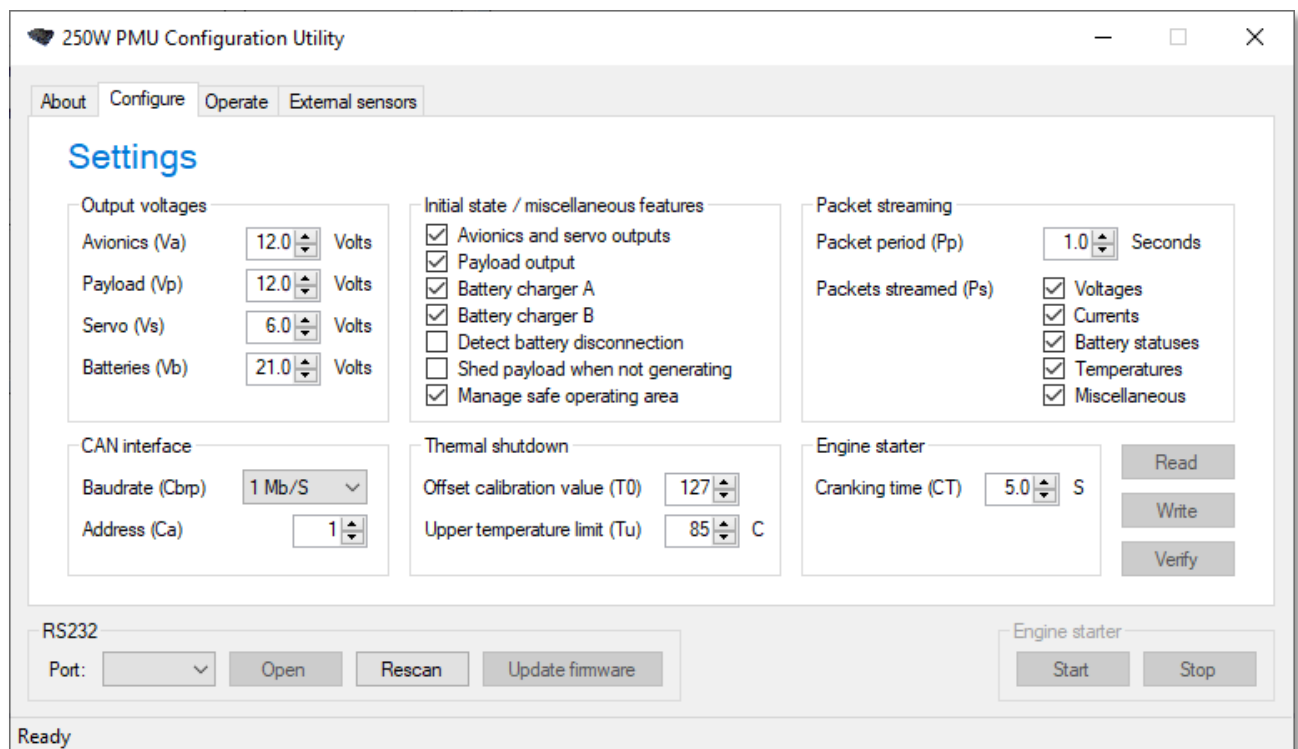
The configuration utility has been updated to version 1.0.0.7 and now allows the CAN Baudrate and CAN address to be set during configuration. The new items are located on the Configure tab as shown below:

Read the settings from the PMU. A warning message will appear – ignore it. Check the CAN interface settings – correct them if necessary – and then write all settings back to the PMU.
